CITY OF SIOUX FALLS  
FALLS PARK, SOUTH DAKOTA  
DECEMBER 10, 2018

VISIT DATE	October 29, 2018
CONTACT/TITLE	<b>Karen Leonard, Deputy City Attorney</b>
LOCATION VISITED	Falls Park in Sioux Falls, South Dakota

## SERVICE OBJECTIVE

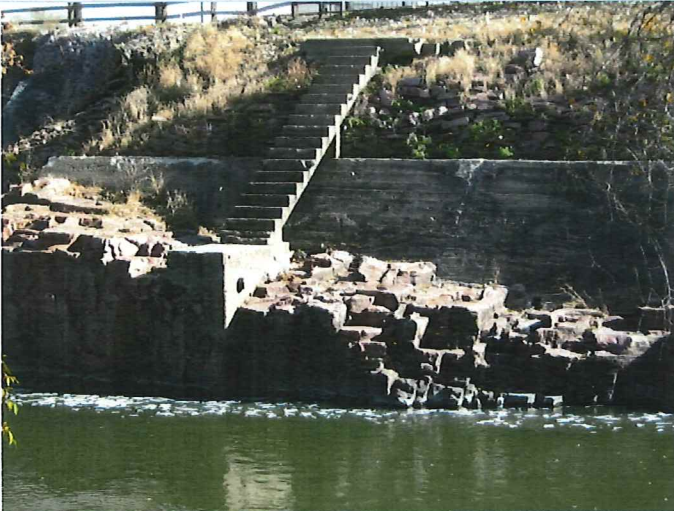
**Pic #1**

**Stairs (historical) just North of Low Head Dam, East bank of river**

2018-3	<p>Extend the metal vertical guard railing beyond its current point to further mitigate access to the area along the East bank of the river, which includes the single set of concrete stairs that are North of the low head dam. These stairs were indicated to have historical significance.</p>

This area represents a potential "attractive nuisance" to Falls Café patrons and the existing wooden fence appears to be easily by-passed by adults, minors, and young children.

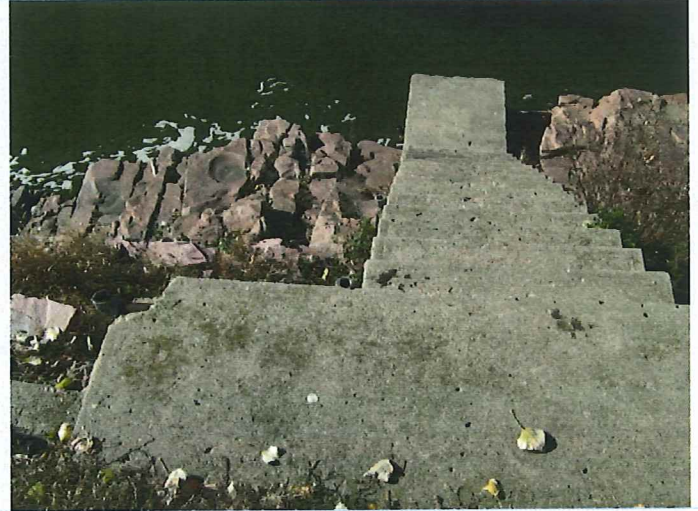
**Pic #2**

**Stairs (historical) just North of Low Head Dam, East bank**

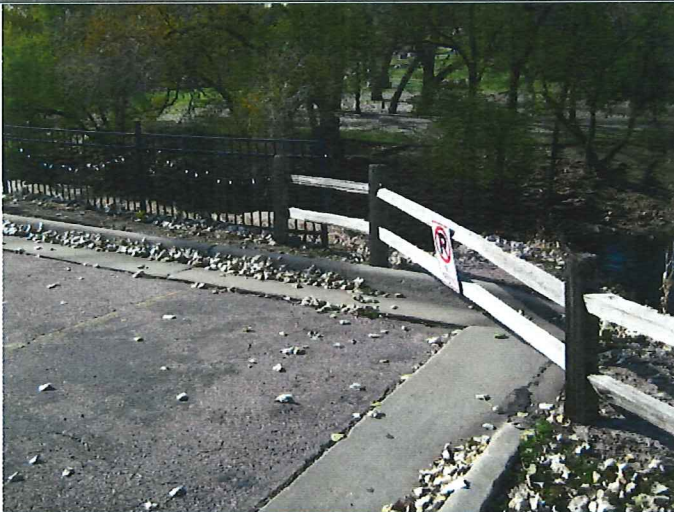
**Pic #3**

**Fencing by Stairs, East side of River**

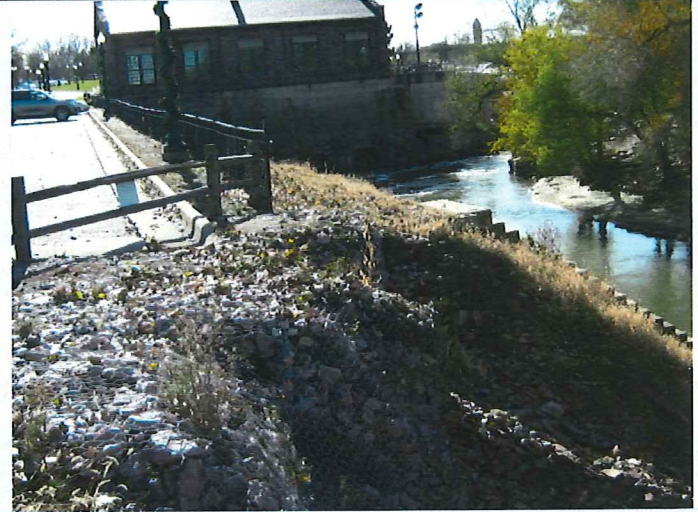
**Pic #4**

**Fencing by Stairs, East side of River**

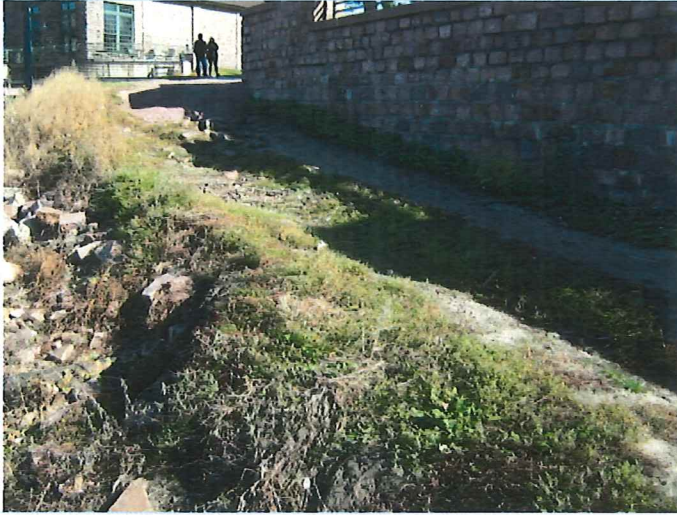
**Pic #5**

**Path leading down to slippery rocks, East bank of river**

Rec #	Recommendation Details
2018-1	<p>Consider making the sandy path along the East river bank less accessible to visitors.</p> <p>This sandy path allows easy access to a large grouping of river rocks made slippery from the mist of the falls. The path was observed to be frequently traveled by visitors, even though a viewing platform was readily available in the immediate vicinity.</p> <p>Possible solutions could include extending the existing metal guard railing, or positioning large boulders or other natural barriers to maintain the park aesthetics while still providing a safeguard to this area.</p> <p>Reference pictures below #5-8</p>
2018-2	<p>Further eliminate access to the rock formation that juts out into the river from the existing viewing platform to reduce the possibility of visitors slipping and falling from potential moisture caused by rain, sleet, or snowfall combined with the steep angle of the rock formation.</p> <p>This could be accomplished by extending the existing guard railing to close the gap between railing and the viewing platform. The rock formation and viewing platform are located on the West bank of the river.</p> <p>Reference pictures below # 9-10</p>

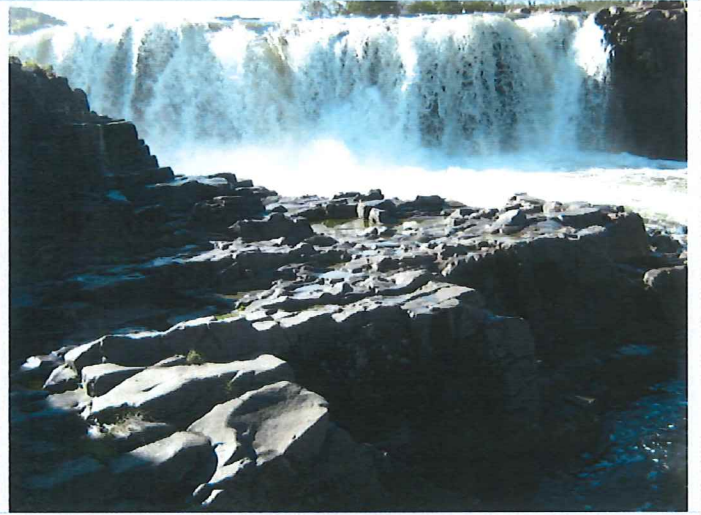
**Pic #6**

**Slippery Rocks, East bank of River**

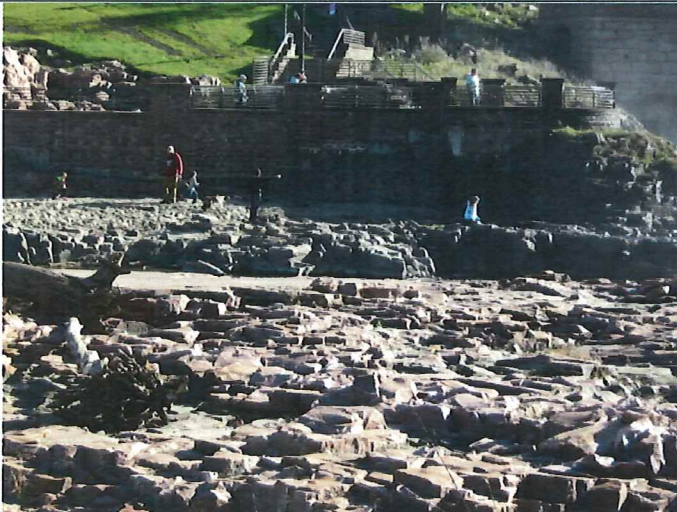
**Pic #7**

**Slippery rocks past sandy path, East bank of river**

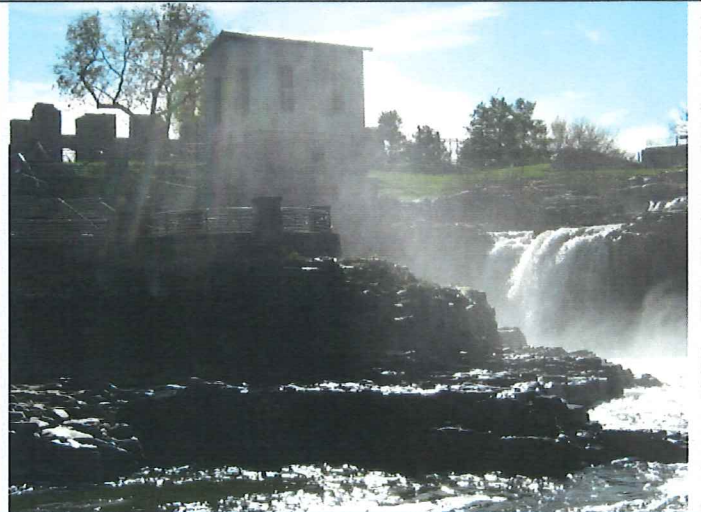
**Pic #8**

**Slippery rocks past sandy path, East bank of river**

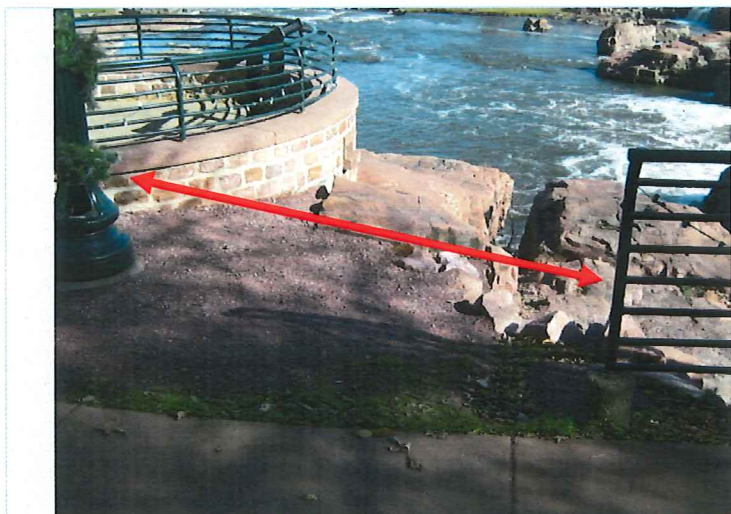
**Pic #9**

**Gap between existing railing and platform, West bank of River**

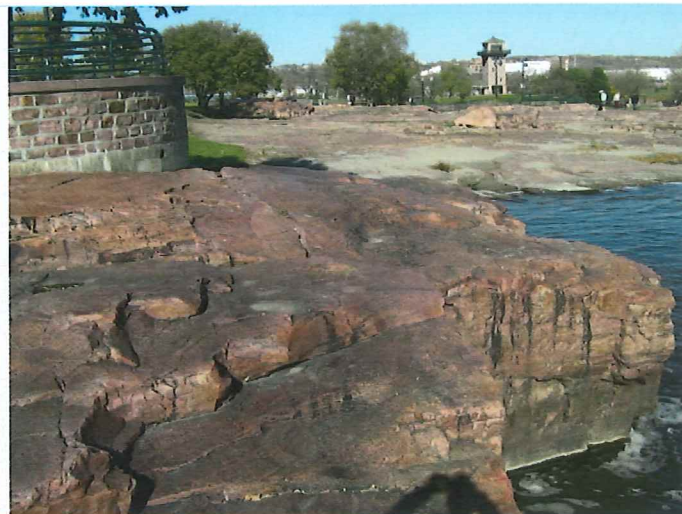
**Pic #10**

**Rocks beyond gap between railing and platform, West bank of River**
